DOT/FAA/SA-88/2

In-Service Evaluation of the Traffic Alert and Collision Avoidance System (TCAS) Industry Prototype

Daniel H. Tillotson
Loren D. Bolstridge
Gary P. Gambarani

May 1988

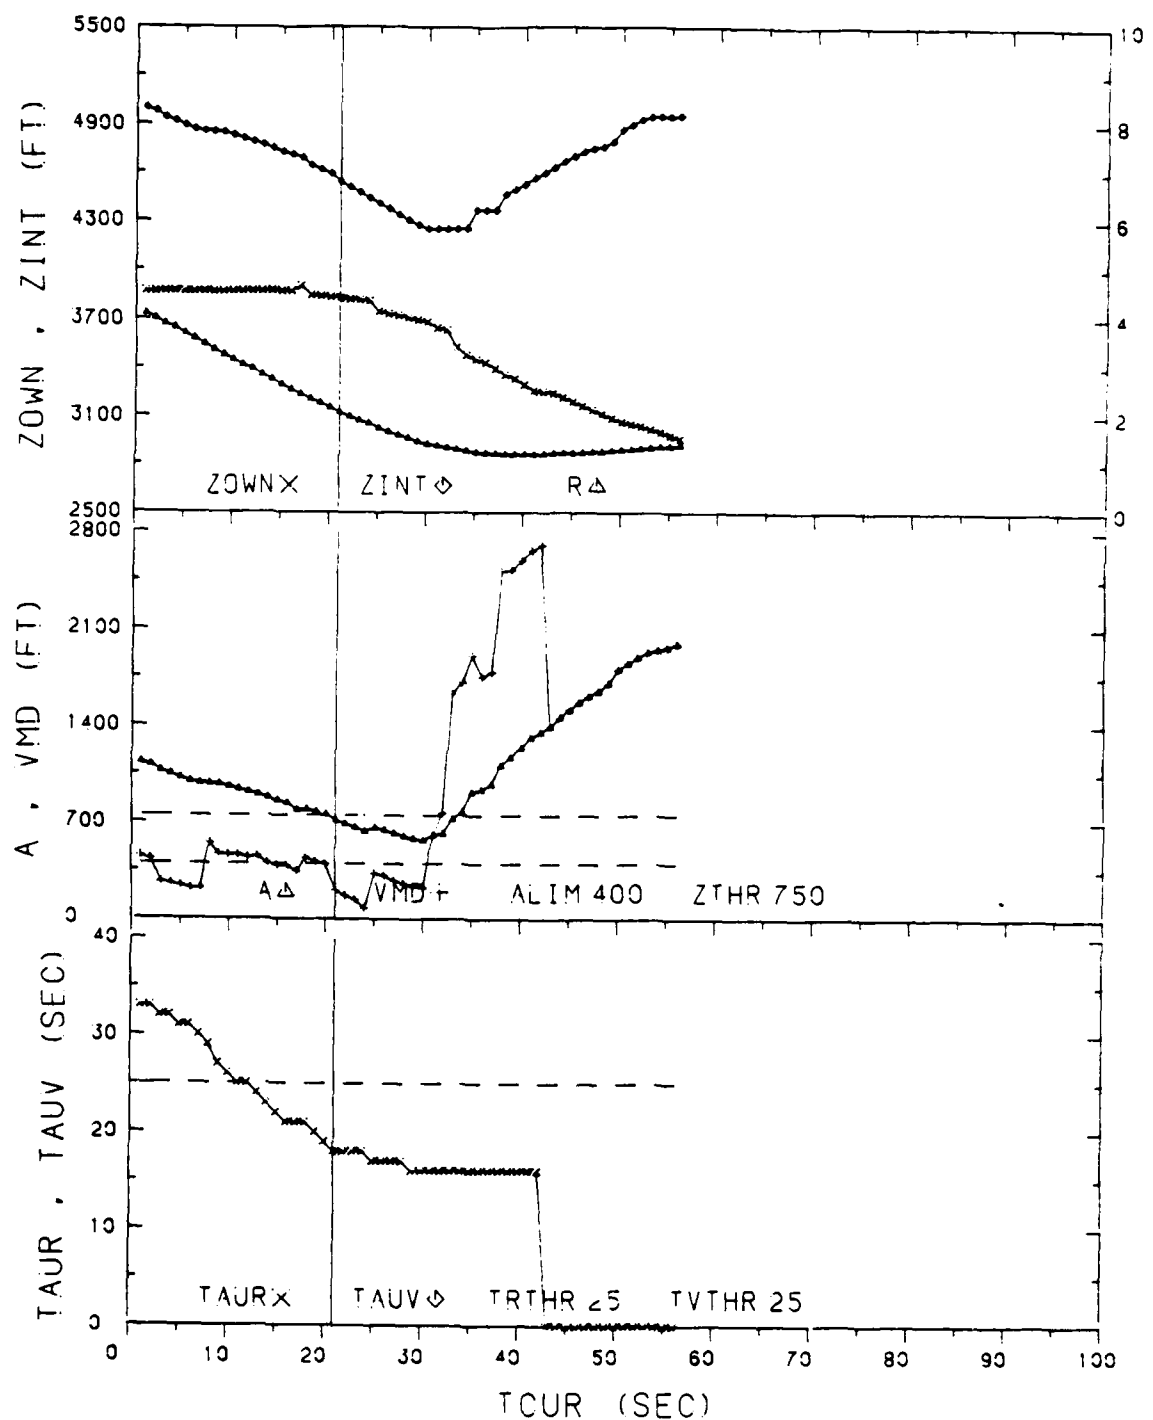
FIGURE D-48
TCAS WARNING 32: PARAMETERS

Warning 32 occurred while there was no observer on board the TCAS aircraft. The recorded data for this encounter are shown in Figures D-47 and D-48.

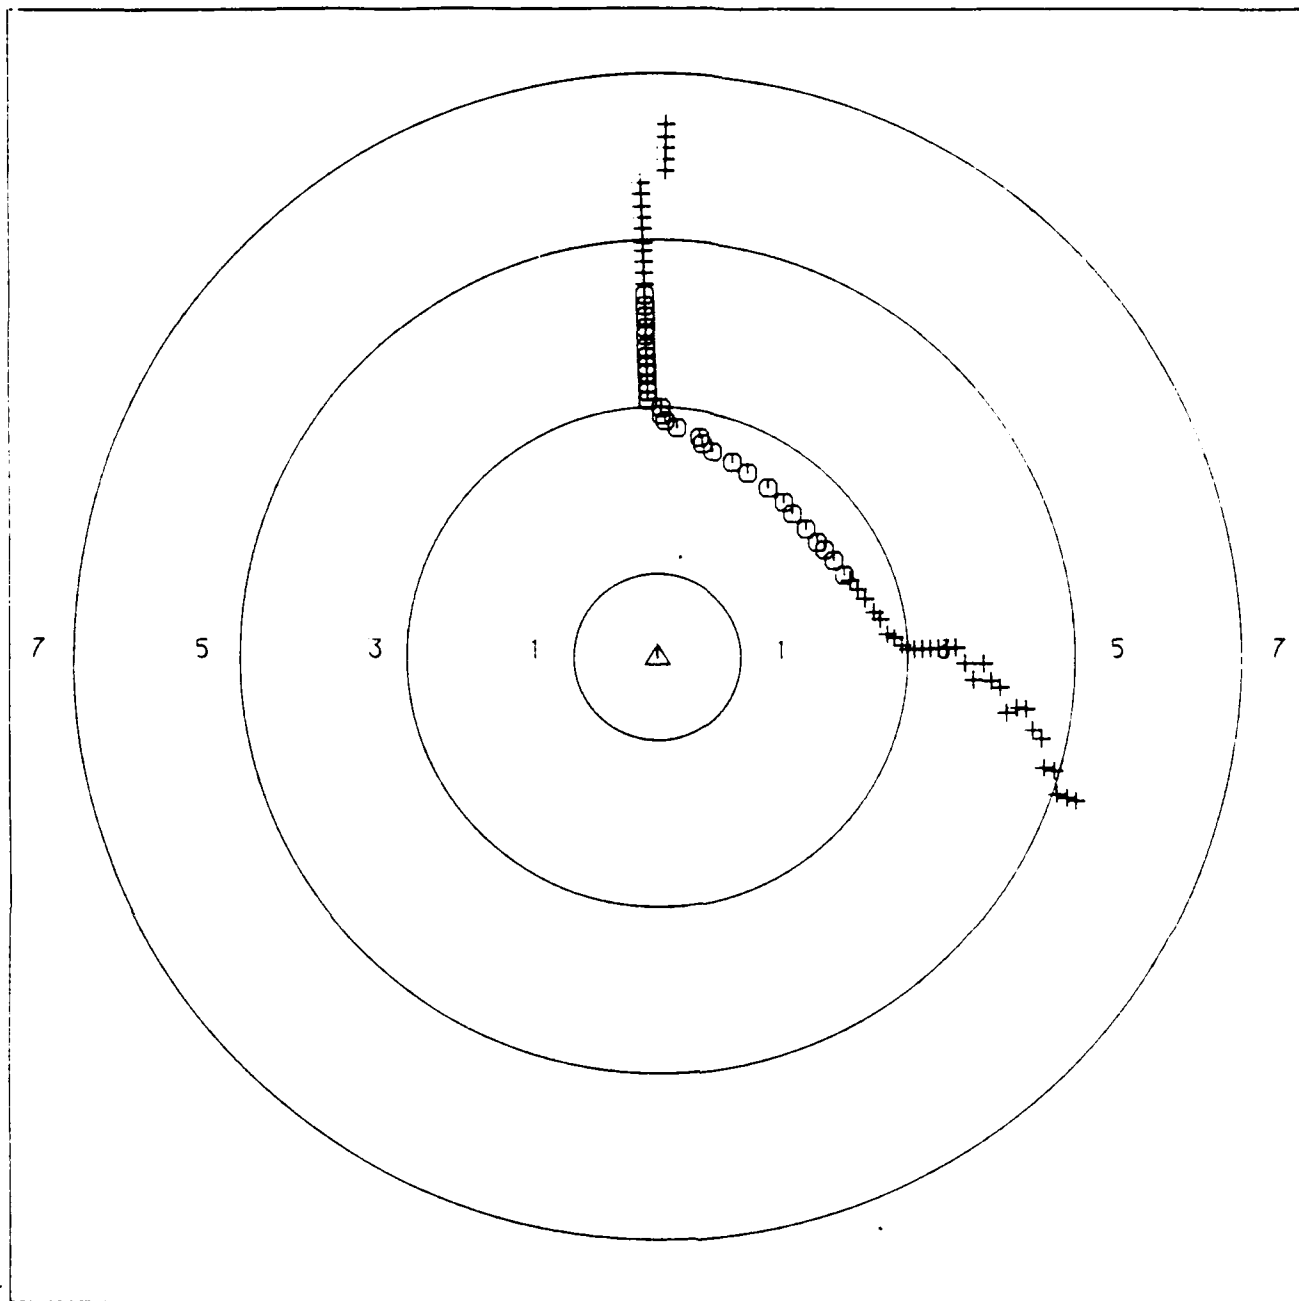
FIGURE D-49
TCAS WARNING 33: BEARING PLOT

Warning 33 occurred while there was no observer on board the TCAS aircraft. The recorded data for this encounter are shown in Figures D-49 and D-50.

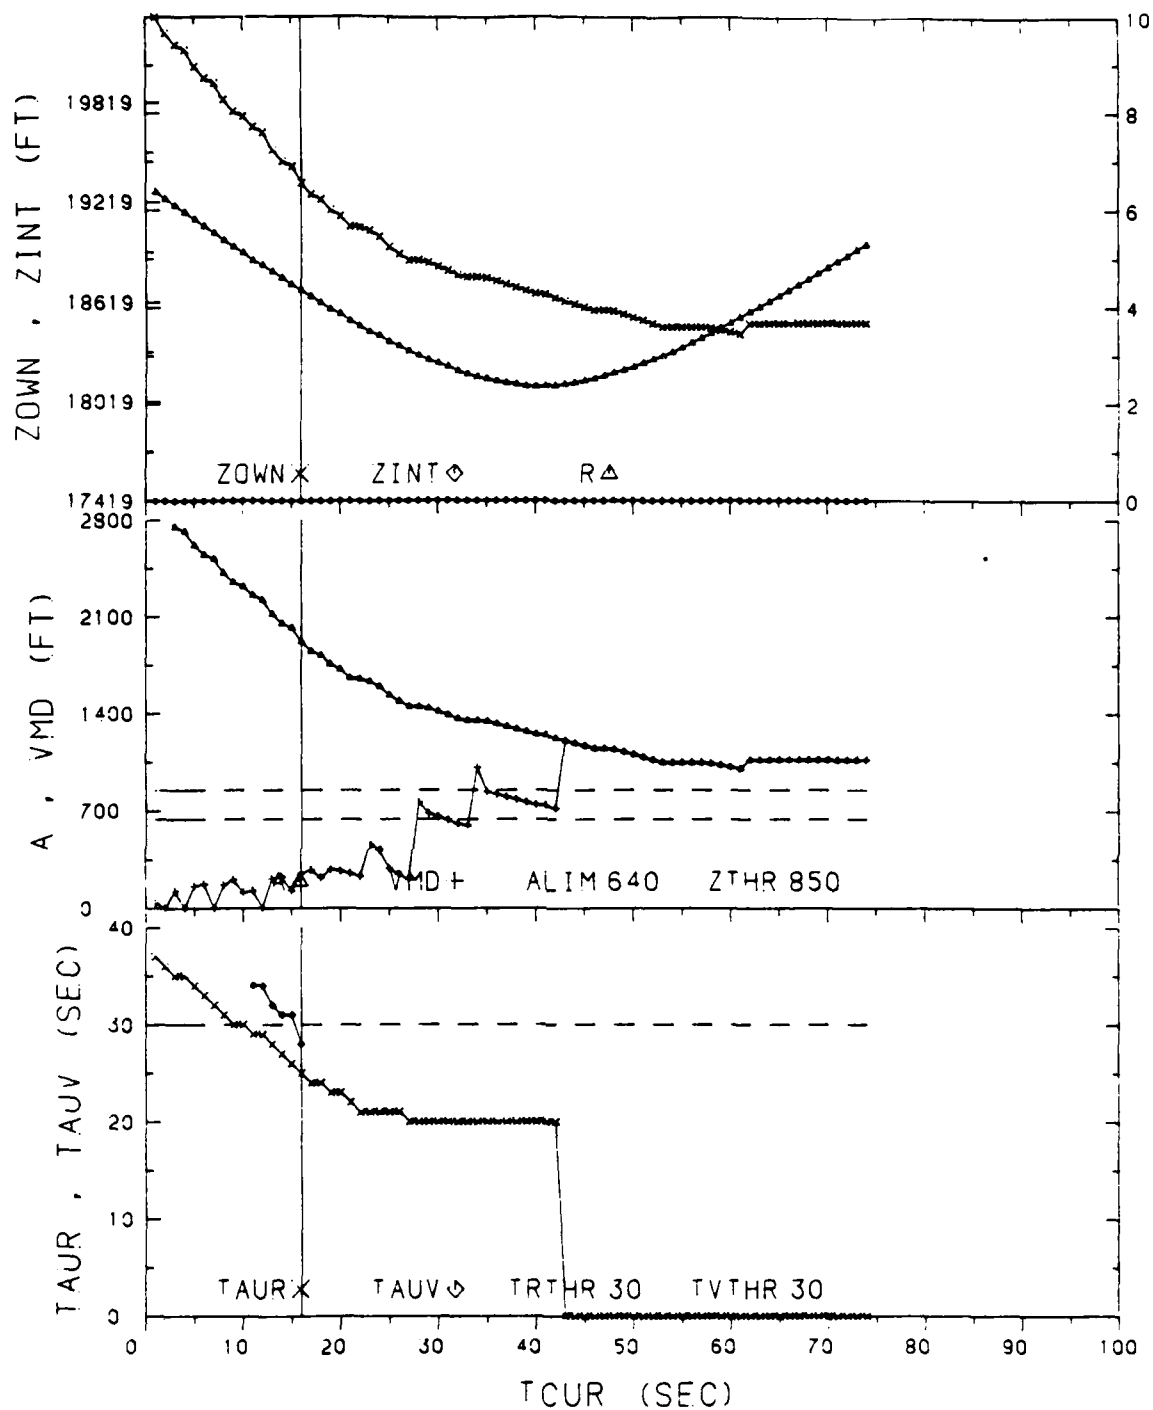
FIGURE D-50
TCAS WARNING 33: PARAMETERS
